Manhole Inspection Summary

Manhole # S33EE_033MH

Location Address: **1123 MARYLAND AVE**

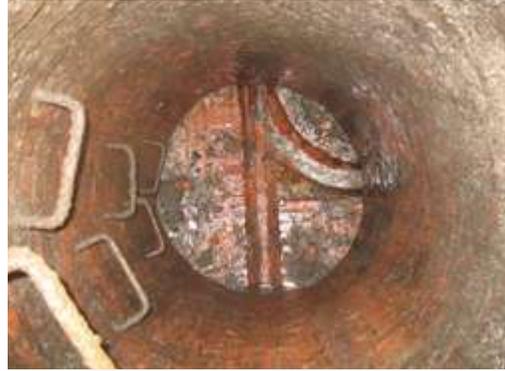
Top View

Corroded steps. Evidence of surcharge - Bench debris.

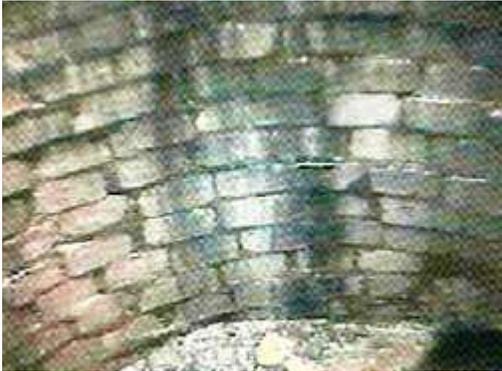
Defect

Barrel deterioration and infiltration.

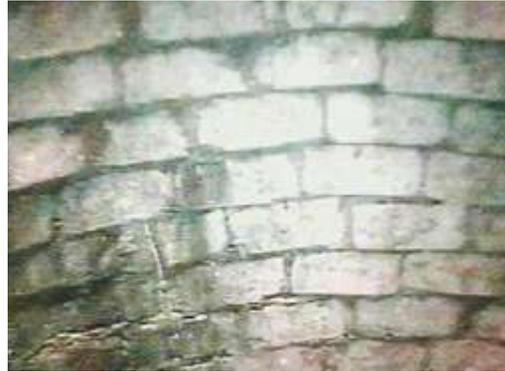
Defect

Barrel infiltration. (Active)

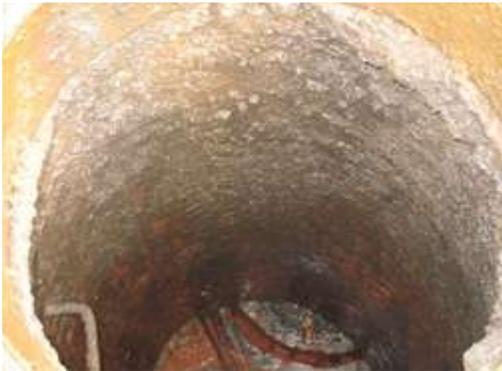
Defect

Frame leaks. Adjustment and Barrel infiltration.

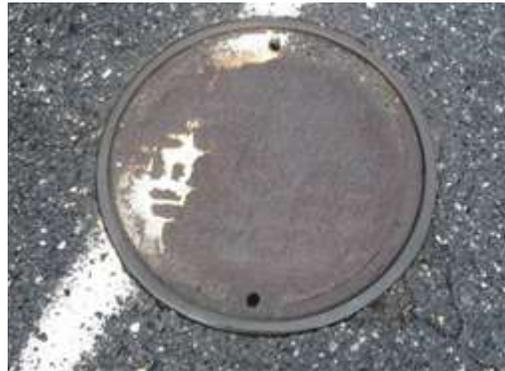
Defect

Worn cover. Subject to ponding.

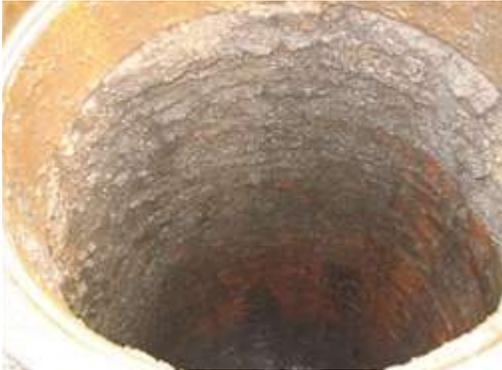
Defect

Frame leaks. Adjustment and Barrel infiltration - other side.

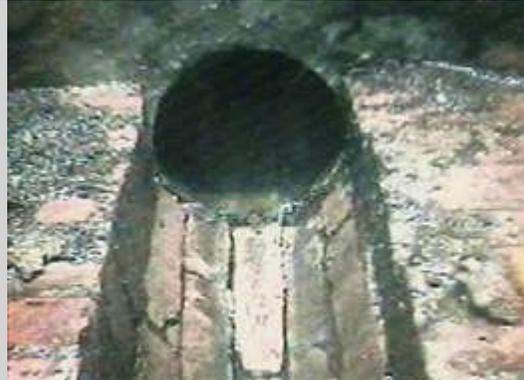
Pipe In @ 6 O'Clock

Channel deterioration.
